2004 Alaska Airport Pavement Condition Report

Scott Gartin, P.E.
State Pavement Engineer
Statewide Materials Section, Alaska DOT&PF
5800 E. Tudor Road
Phone: (907) 269-6244 Fax: (907) 269-6231
Email: scott_gartin@dot.state.ak.us

TOK JUNCTION AIRPORT - 2004

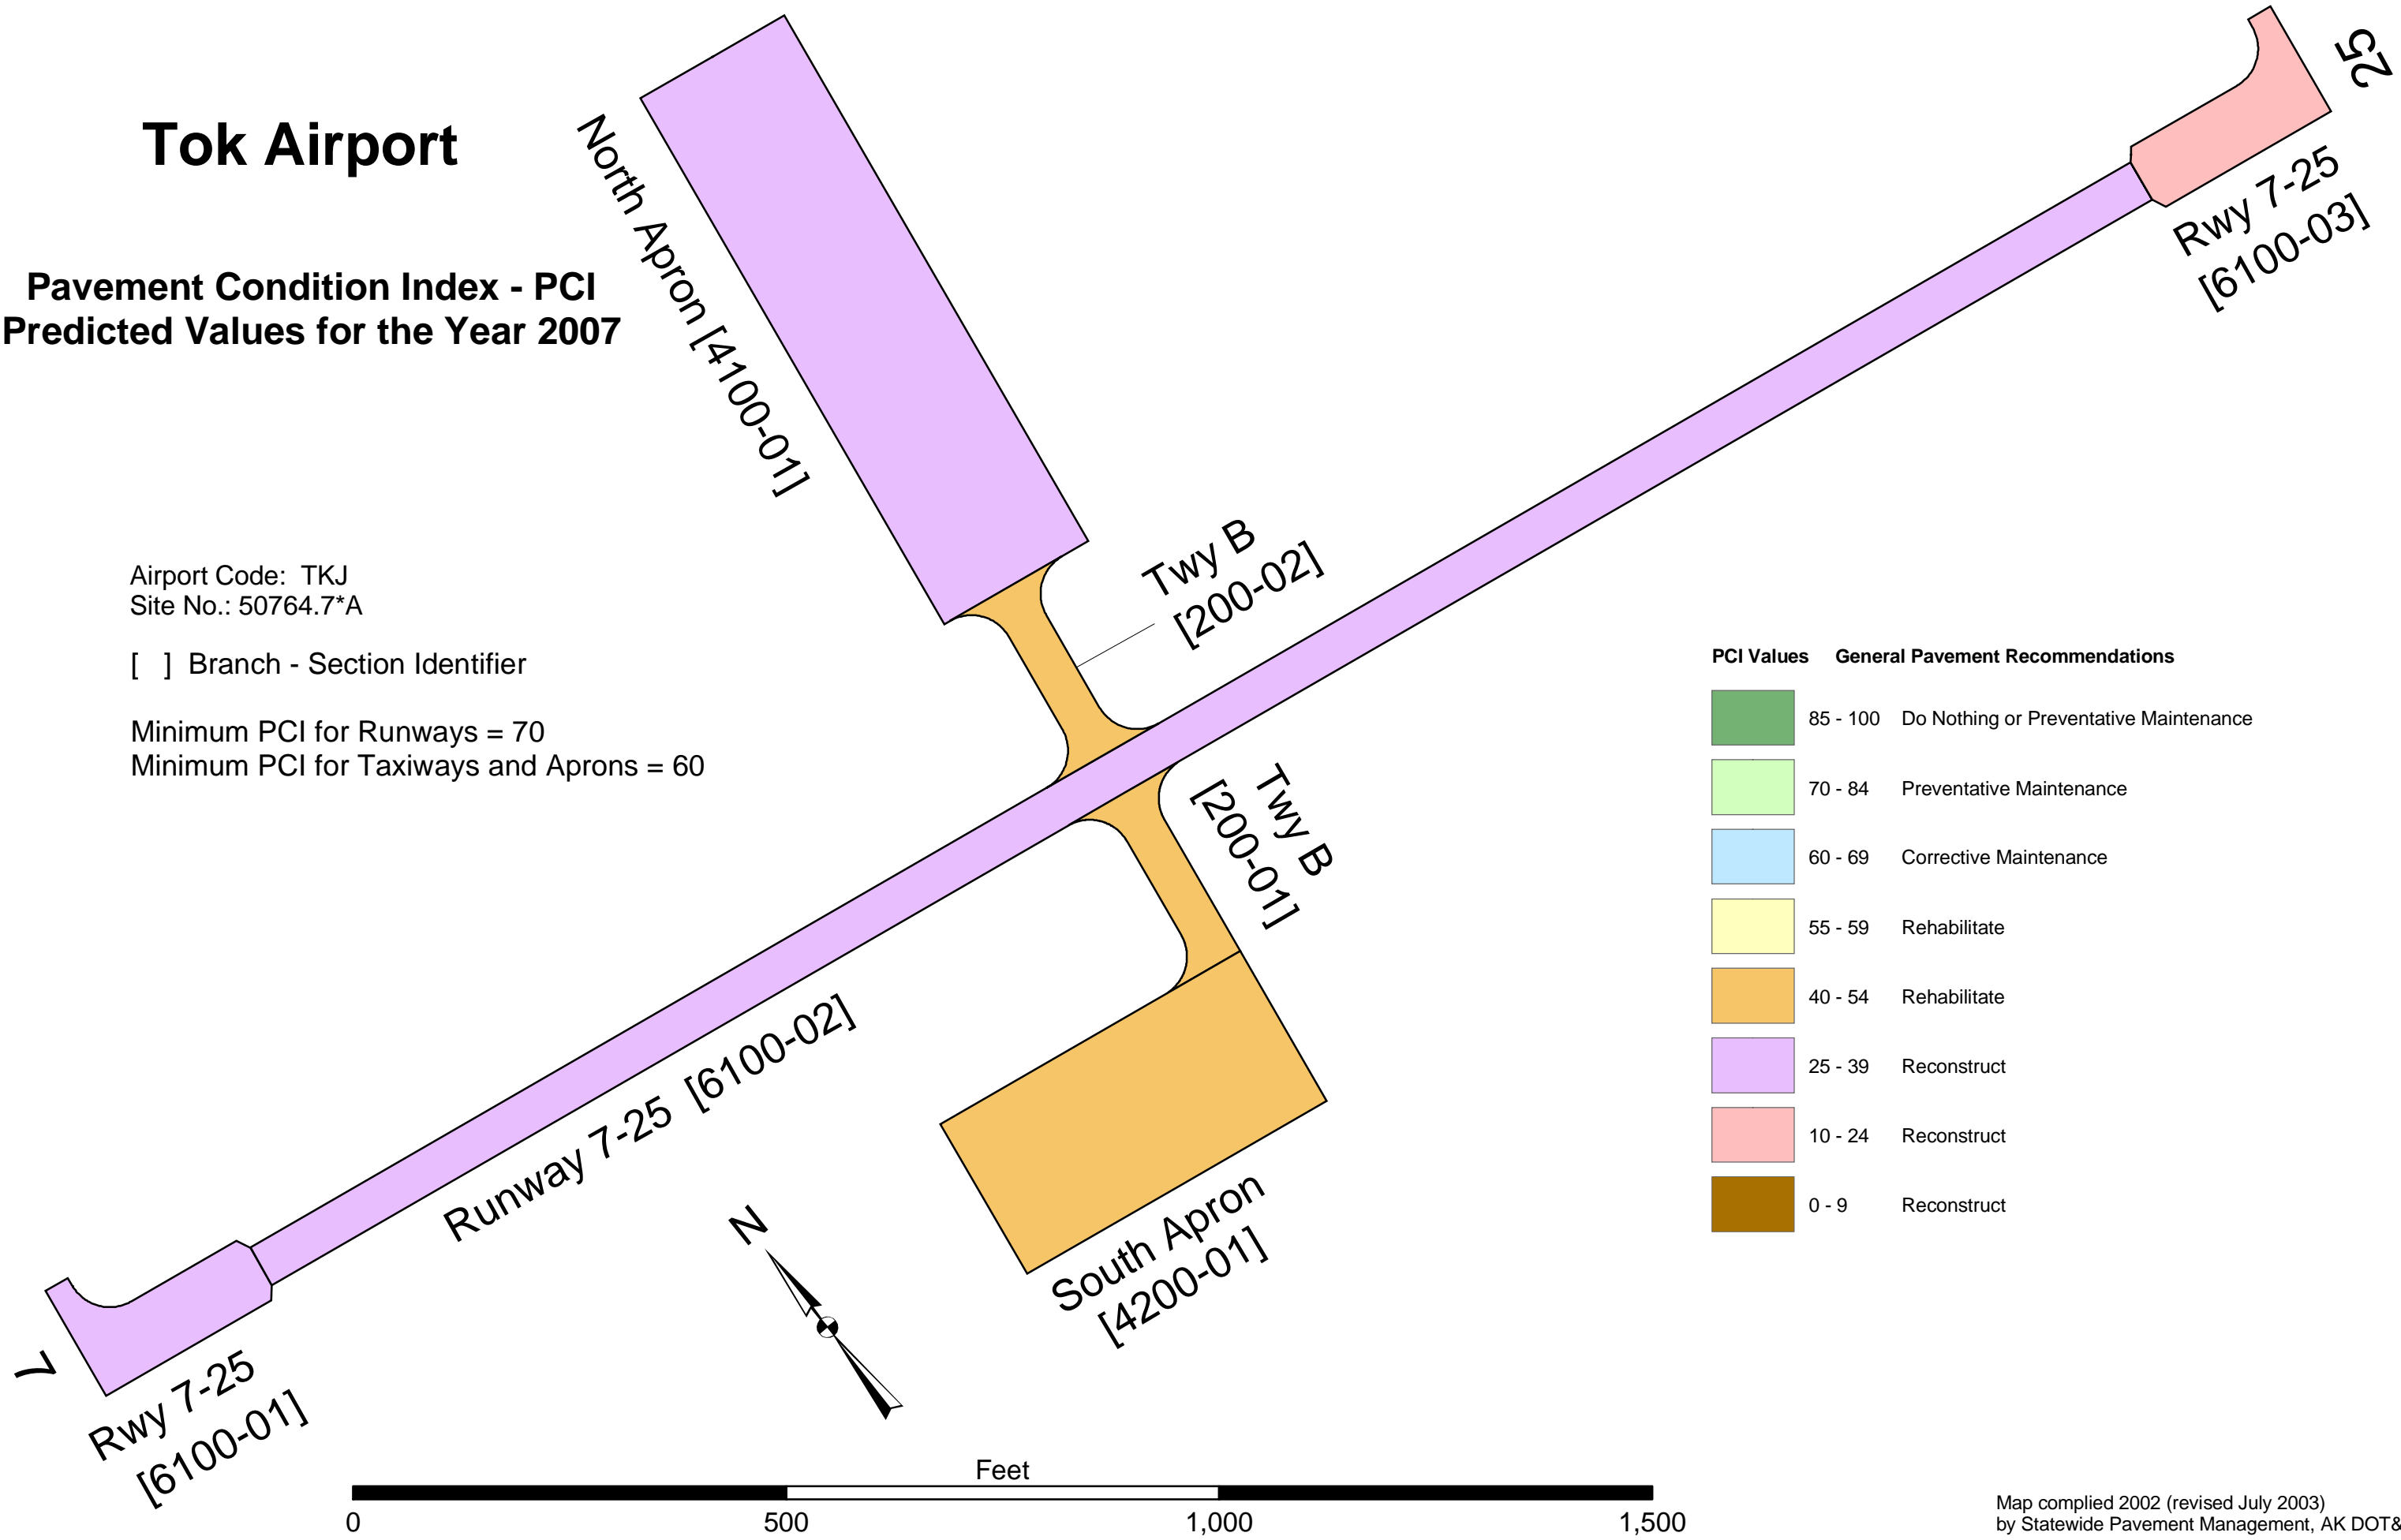
Pavement Condition Index - PCI Predicted Values for the Year 2007

Minimum PCI for Runways = 70
Minimum PCI for Taxiways and Aprons = 60

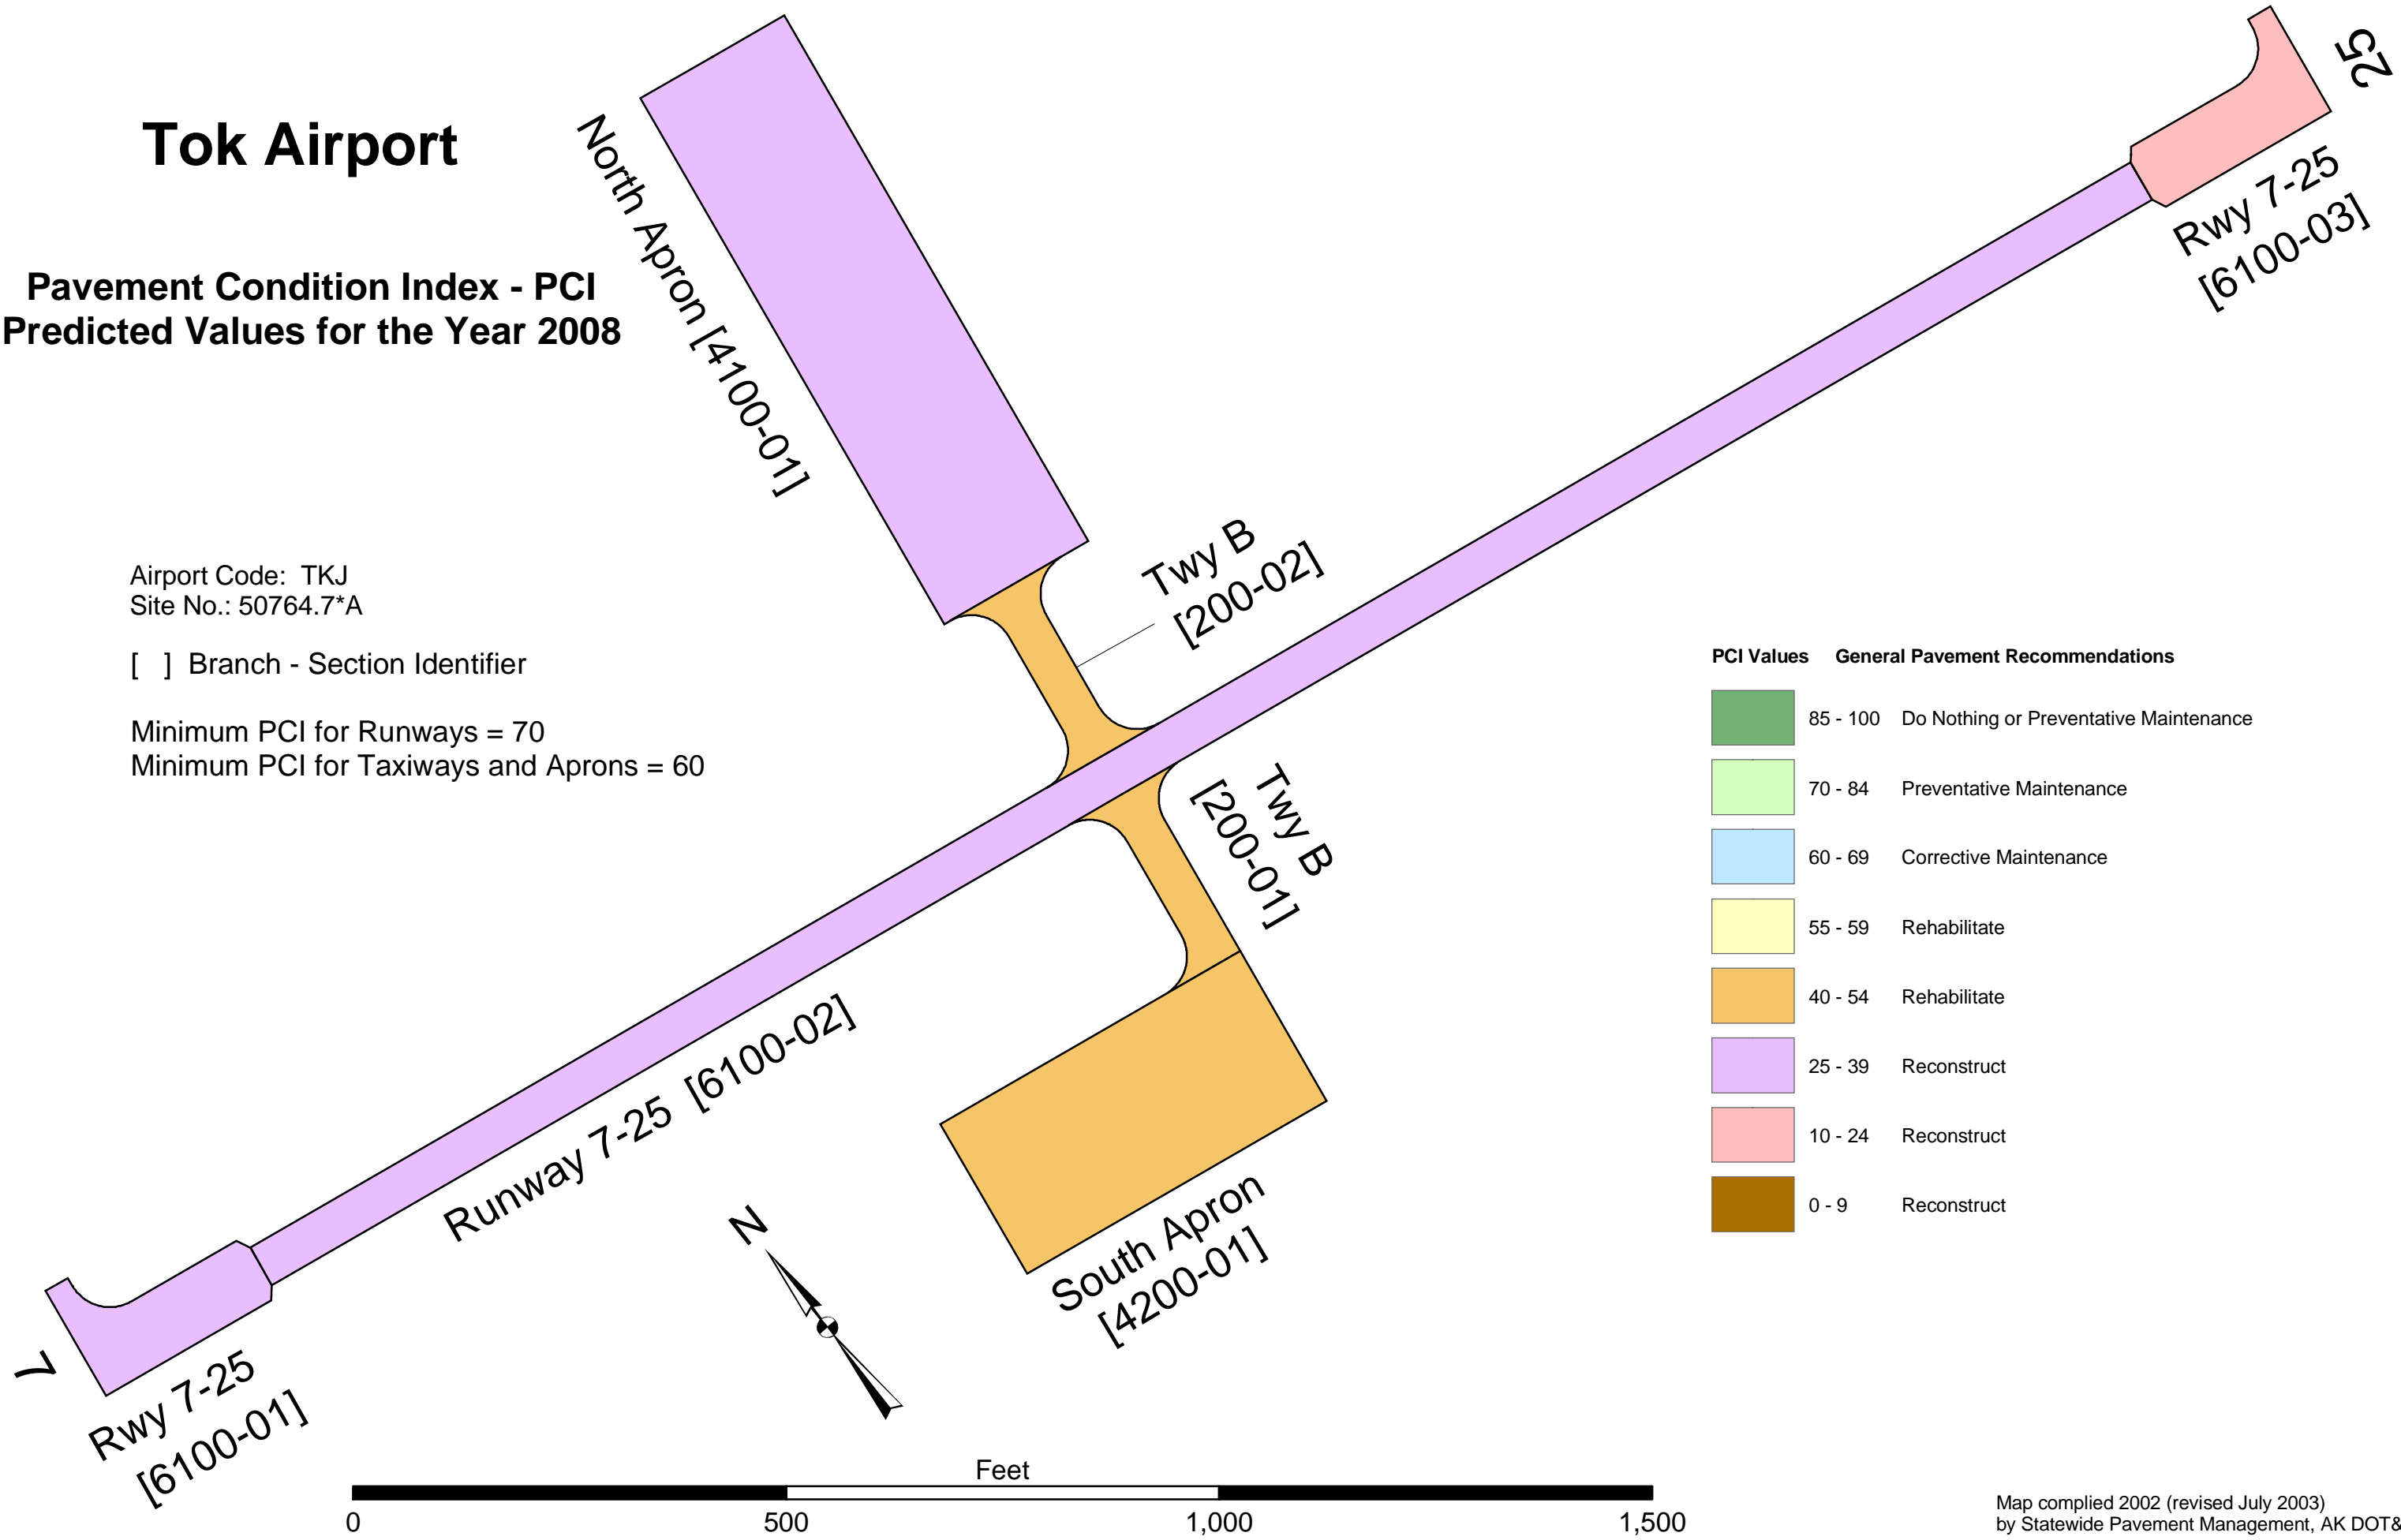
Pavement Condition Index - PCI Predicted Values for the Year 2008

Minimum PCI for Runways = 70
Minimum PCI for Taxiways and Aprons = 60
